**RE: Executive Summary of Structural Assessment, 208 Bates Avenue**

Re: 208 Bates – Structural Assessment  
St. Paul, MN  
ERA Commission Number: 2010-096

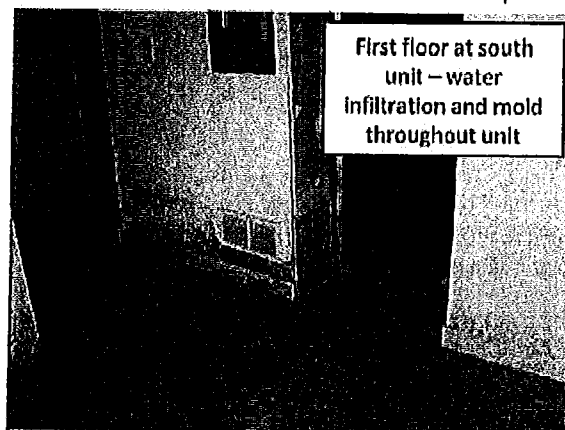
- 1) The walls and ceilings were covered with drywall and painted white, so the structure was not observable. However, it was apparent that there has been moisture in the walls and ceilings. Interior finishes have been damaged by water and mold.
- 2) Most of the windows appeared to have mold around the base of the window.
- 3) The first floor units in the back of the building had large amounts of water damage and mold growing on the walls, ceilings, and floors. Since the back of the building at first floor is below grade, it is likely that ground water is seeping through the wall.
- 4) Some walls are noticeably out of plumb and slightly sagging.

First floor at south unit – water infiltration and mold throughout unit

- 1) If water proofing is applied to the exterior face of the below grade walls, the existing wall may not be adequate to support the additional hydrostatic lateral pressures.
- 2) In order to assess the condition of the bearing walls and the damage that the moisture infiltration has done to the structure, it will be necessary to remove the interior sheathing on the ceilings and walls throughout the building.
- 3) Remove or reinforce any structural framing that has deteriorated due to water damage.

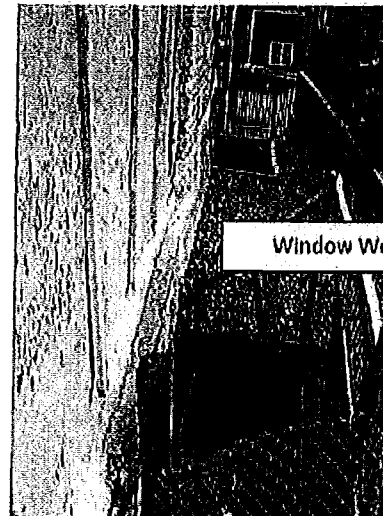
Window Wells

- 1) Window wells have been constructed with plywood and 2x wood framing retaining the earth pressures. This construction is not code compliant.

- 1) Remove and replace non-compliant construction.
